Case Study

Camscan mobilised by Qatar Shell GTL for well survey

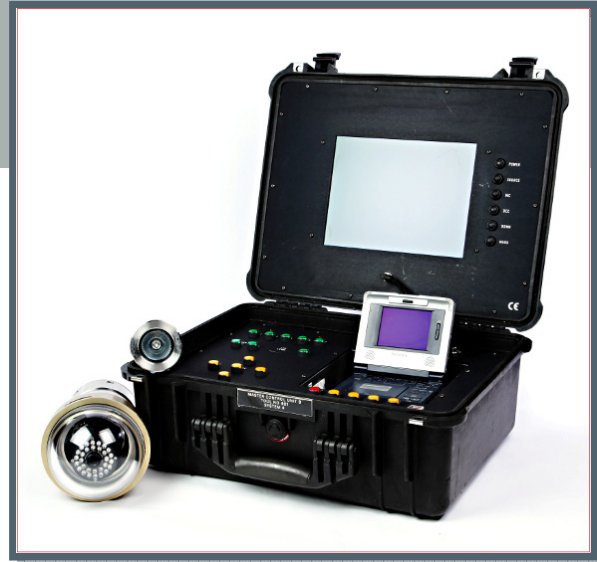
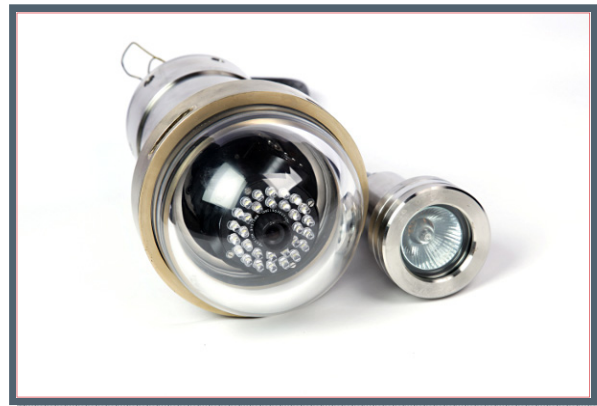
Despite several attempts it proved impossible to make up the running tool back into the casing hanger. The string of casing was pulled back to surface. Mudline Hanger thread damage was suspected and an inspection inside the ML hanger was called for.

Claxton mobilised a Camscan system offshore at short notice, this was deployed down-hole on drill pipe to inspect the mudline suspension hanger threads and seal surfaces.

Camscan images enabled the Drilling Supervisor to make the decision to utilise a Ratch-a-Latch tieback sub. This was made up successfully, the integrity of the tieback confirmed and drilling continued.
